LOW FRICTION HULL COATINGS FOR ICEBREAKERS

PHASE II, PARTS I AND II

TECHNICAL REPORT

**DEPARTMENT OF TRANSPORTATION
UNITED STATES COAST GUARD**

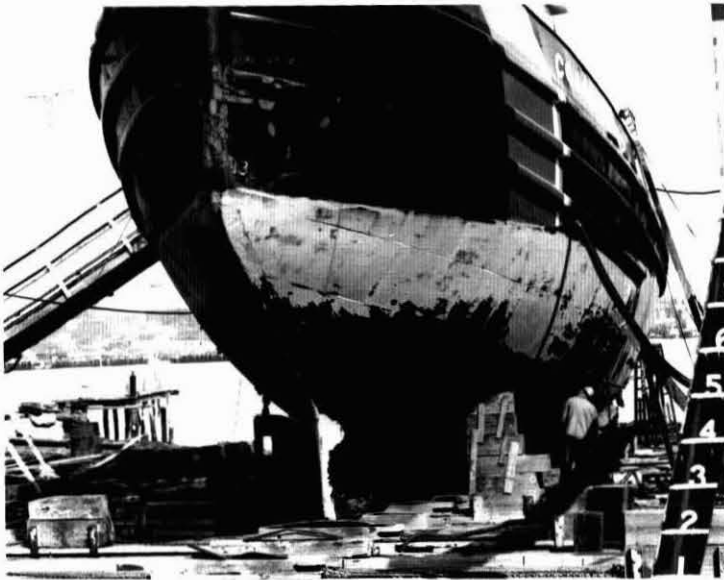
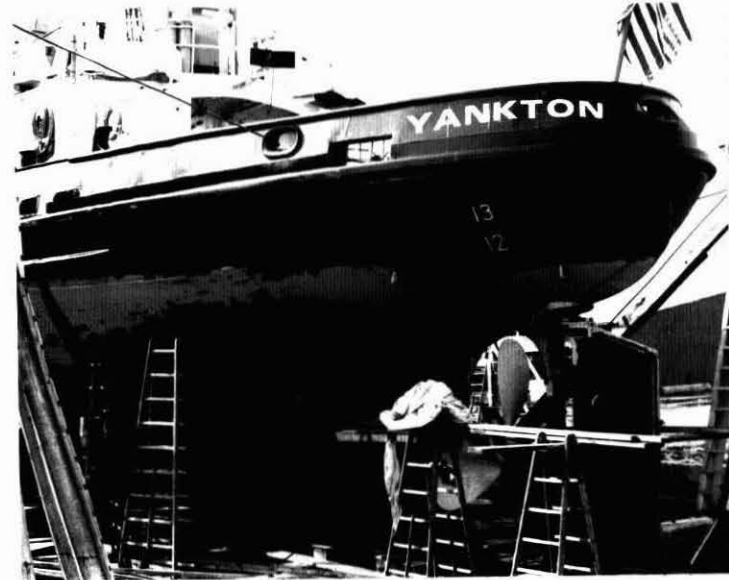
Figure II-1a Condition of the Hull of the US Cutter Yankton before Recoating

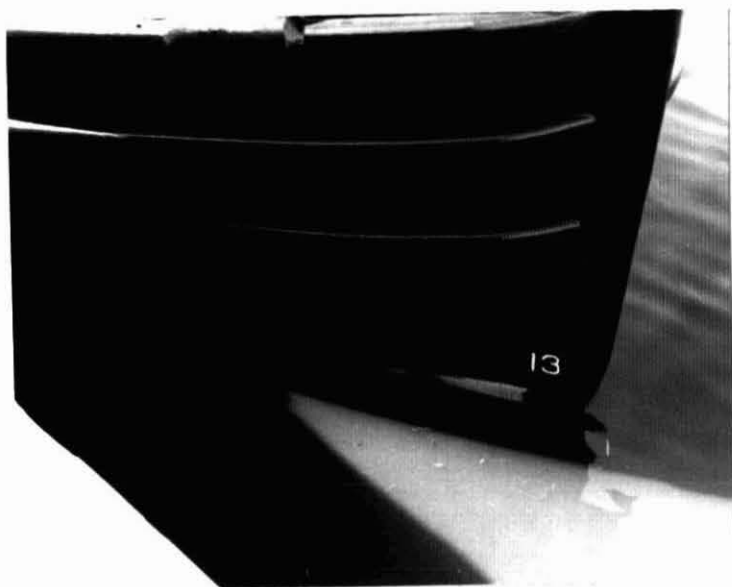
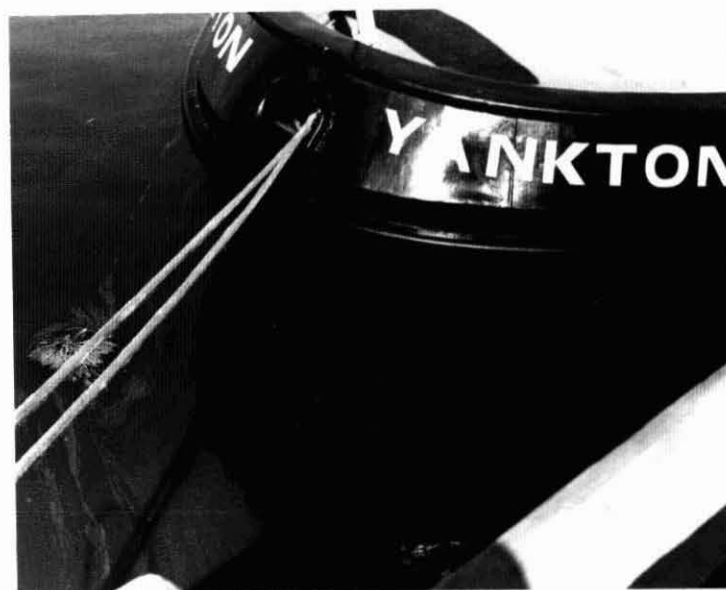
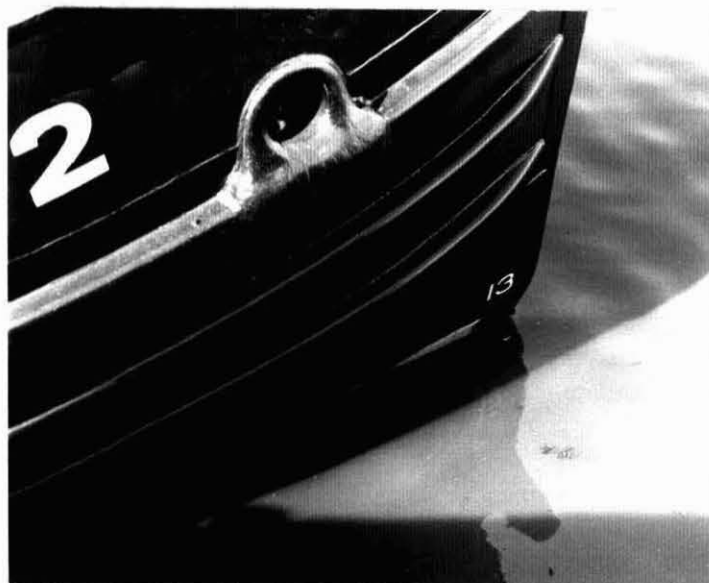
Figure II-4 Photographs of the US Cutter Yankton after Icebreaking Service

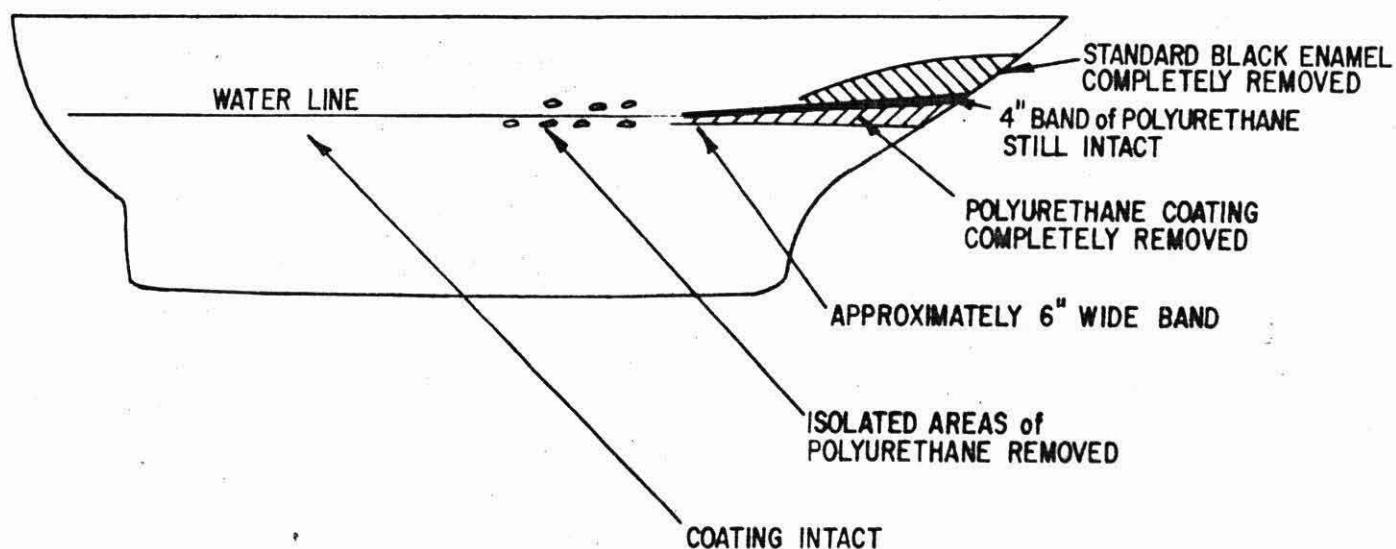
After the ship had been in the "pack ice" it was noticed that a band of polyurethane at the water line and below it was being removed. This is attributed to the erosion or abrasive action of the small particles of ice impinging on the hull. The total width of the urethane being removed at the bow was not visible; however, the width could be seen approximately ten feet from the bow and estimated to be about six inches. About 20 feet back the coating was intact at approximately 90% of the water line. From midship to stern, the coating appeared to be 100% intact at the water line. The diagram below shows the approximate extent and pattern of the damage.

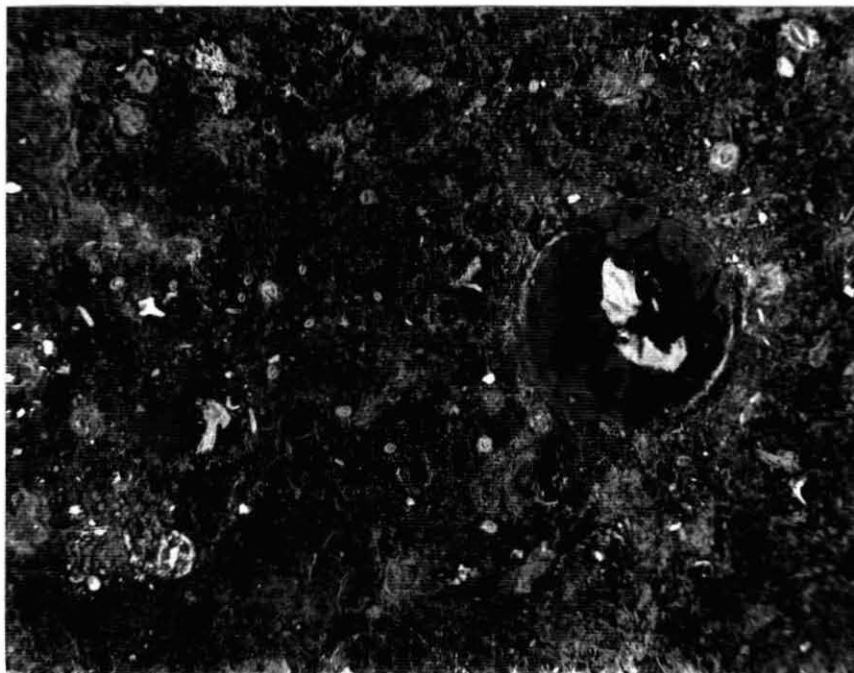
Figure II-9 Surface Appearance of the Coating on the Hull of the USCG Cutter Sauk after Service. Upper photo shows the typical appearance of the coating as "dry docked". Lower photo shows the barnacles removed without damage to the coating magnification $\times 3$.

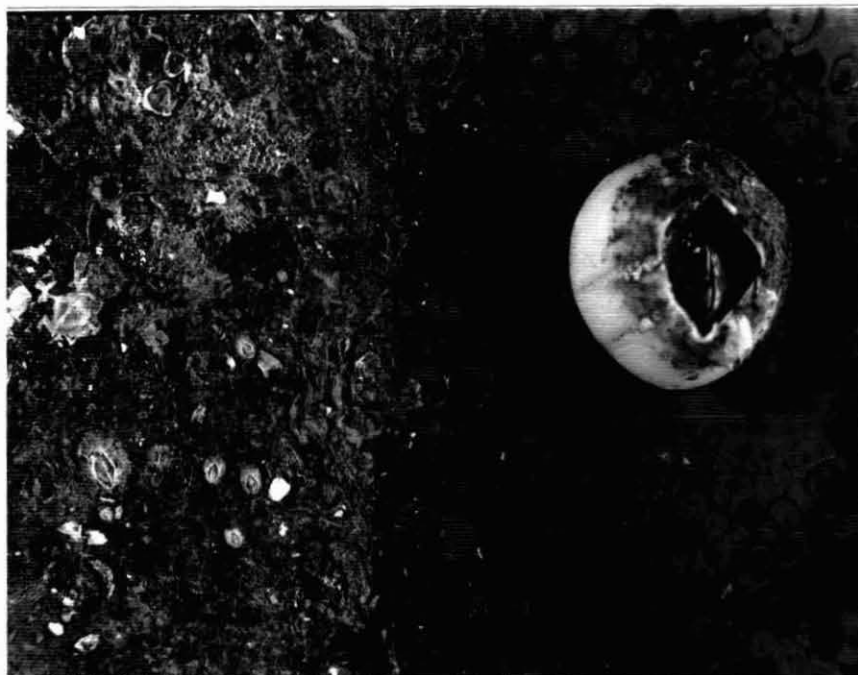
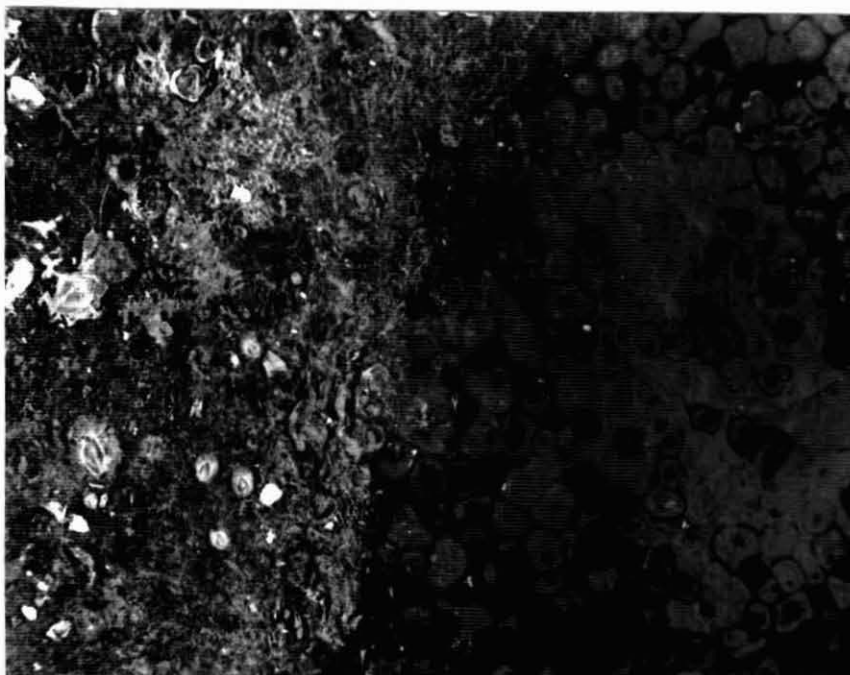
Figure II-10 Surface Condition of the USCG Cutter Sauk Coating before (Left) and after (Right) Washing with Water. Upper photo shows position of a barnacle on the cleaned surface. Lower photo shows the barnacle removed. Magnification 3X.

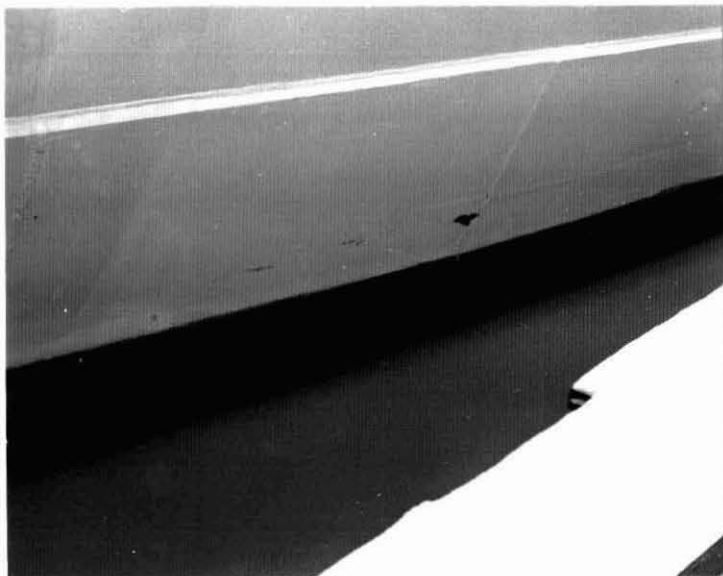
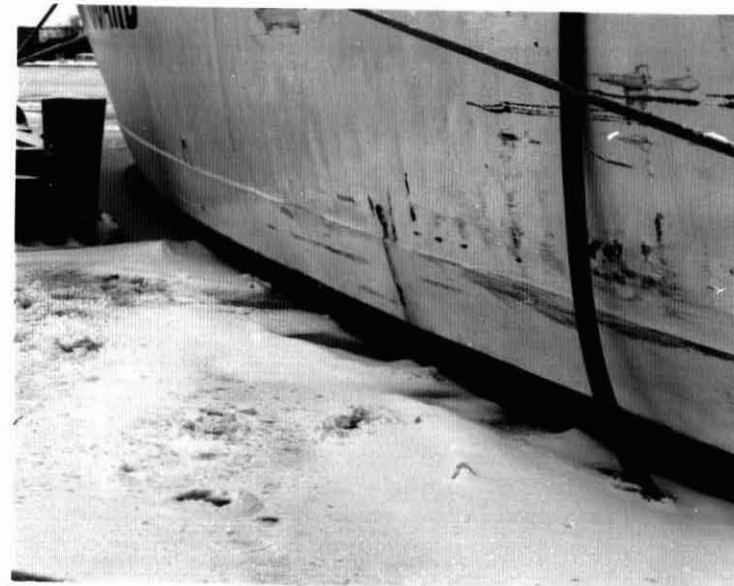
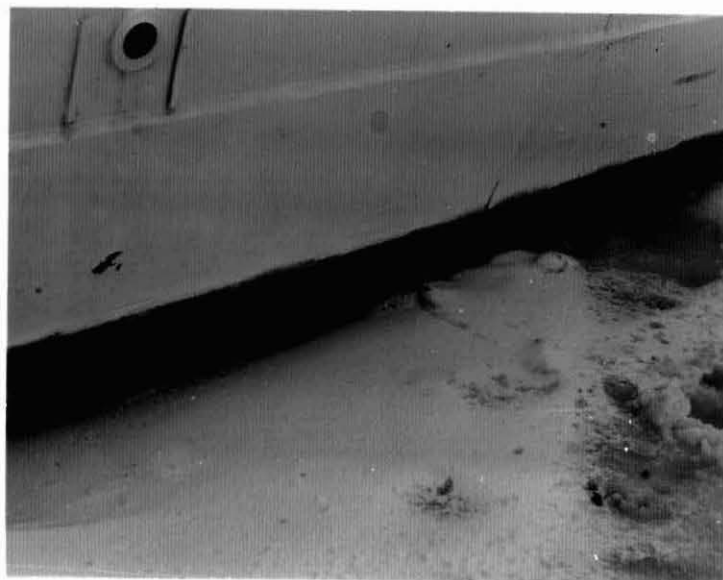
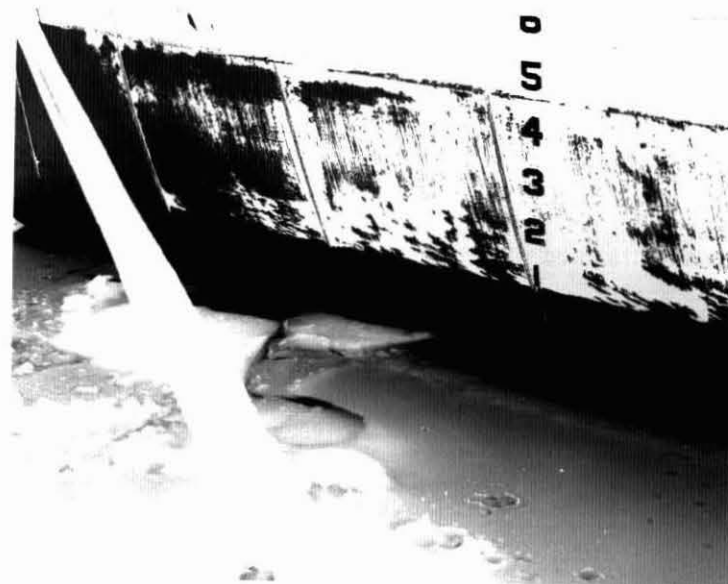
Figure II-15 Photographs of the Ice Line of the Hull of the Cutter Mackinaw after Icebreaking Service

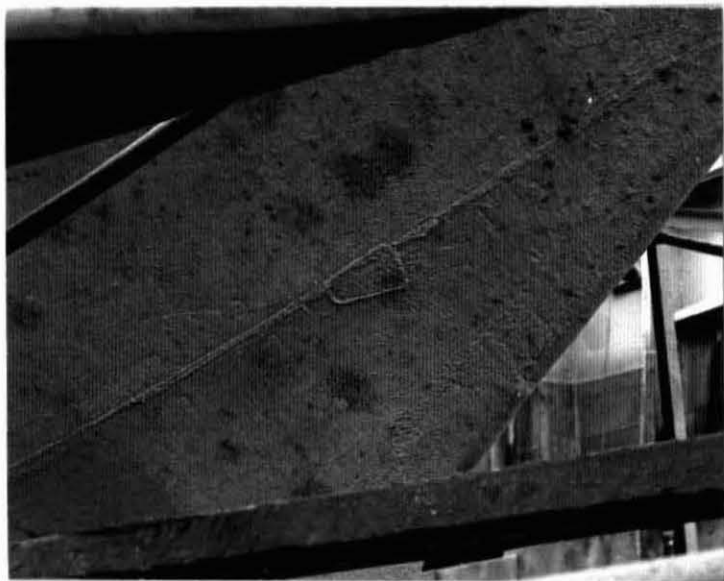
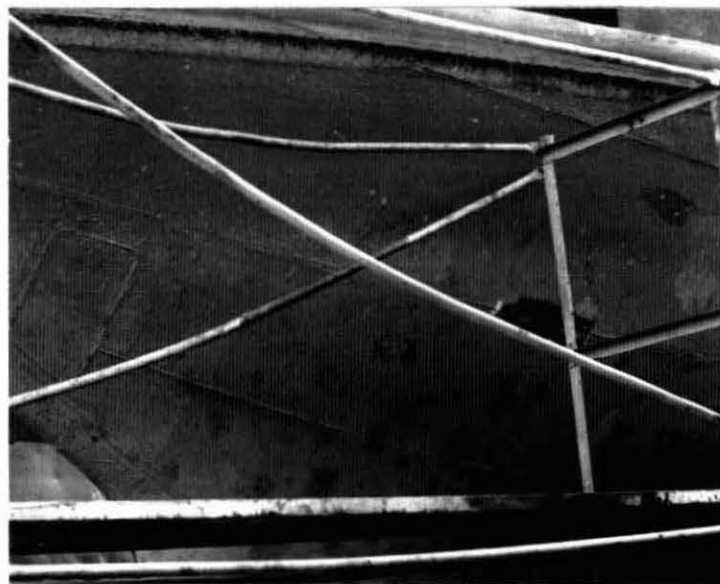
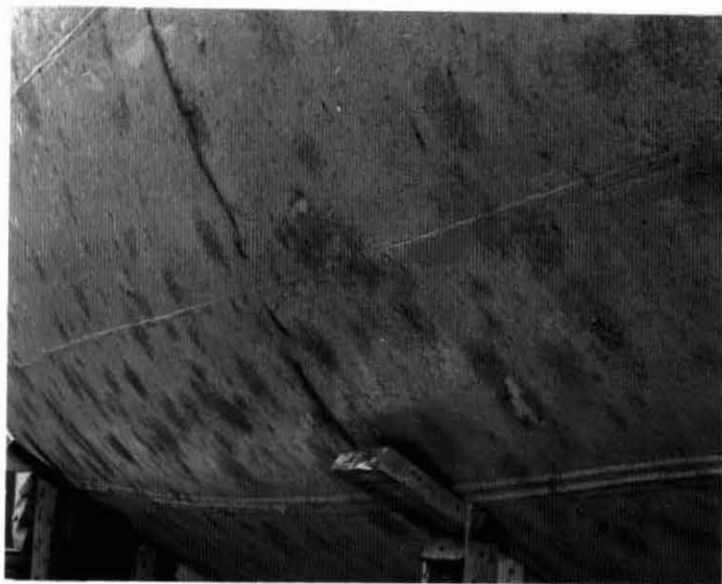
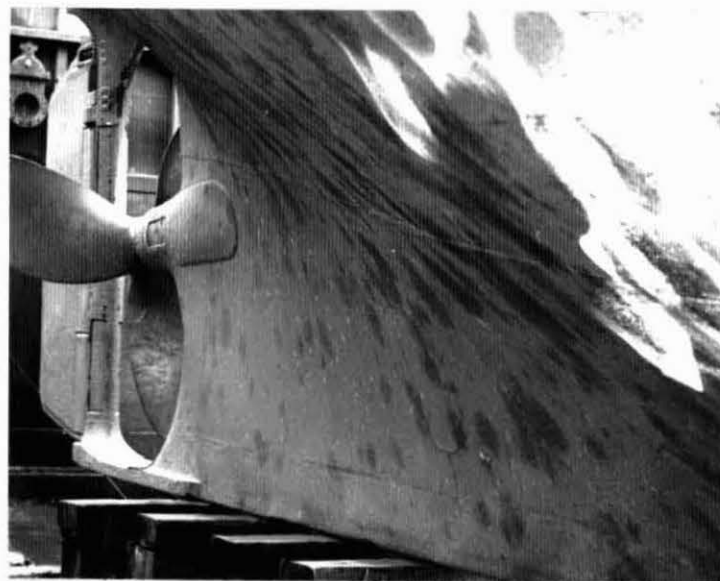
Figure II-21 Condition of Hull of the USCG Cutter Raritan before Cleaning

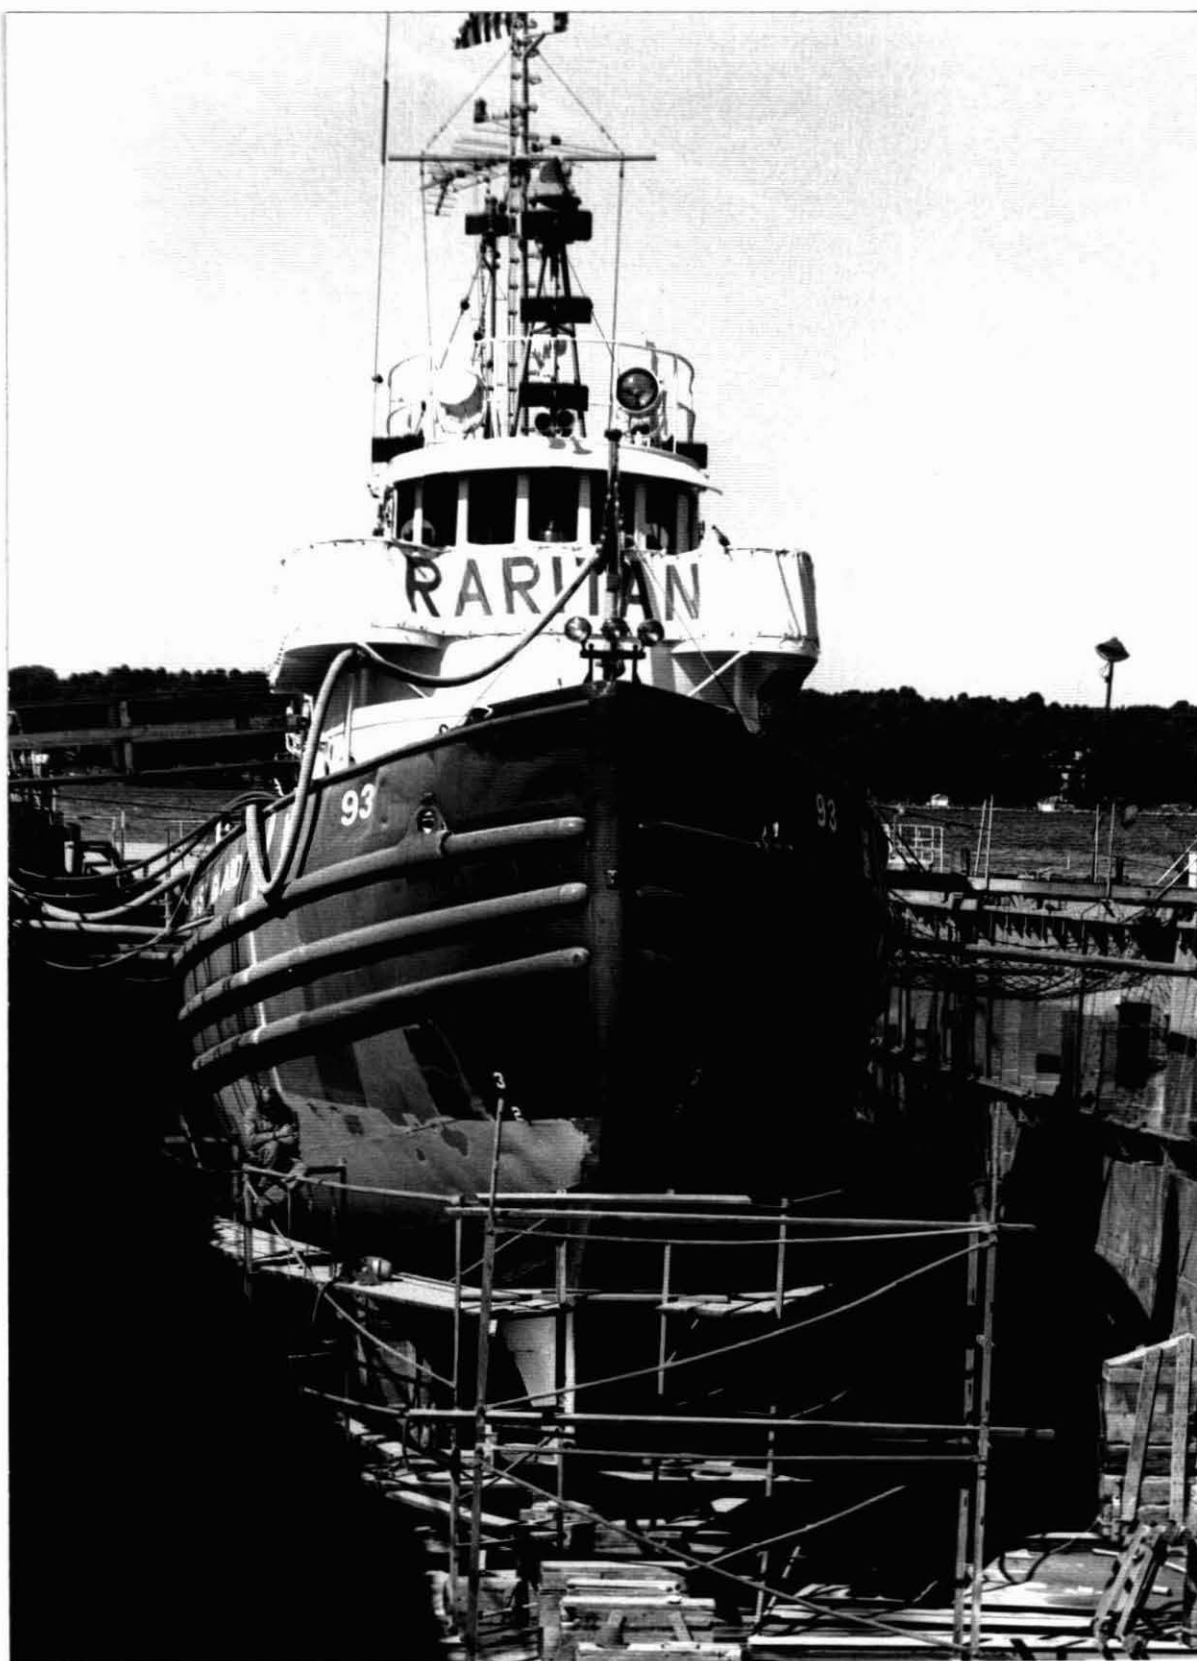
Figure II-23 Condition of the Hull of the Cutter Raritan after Grit Blasting the Damaged Areas for Repair

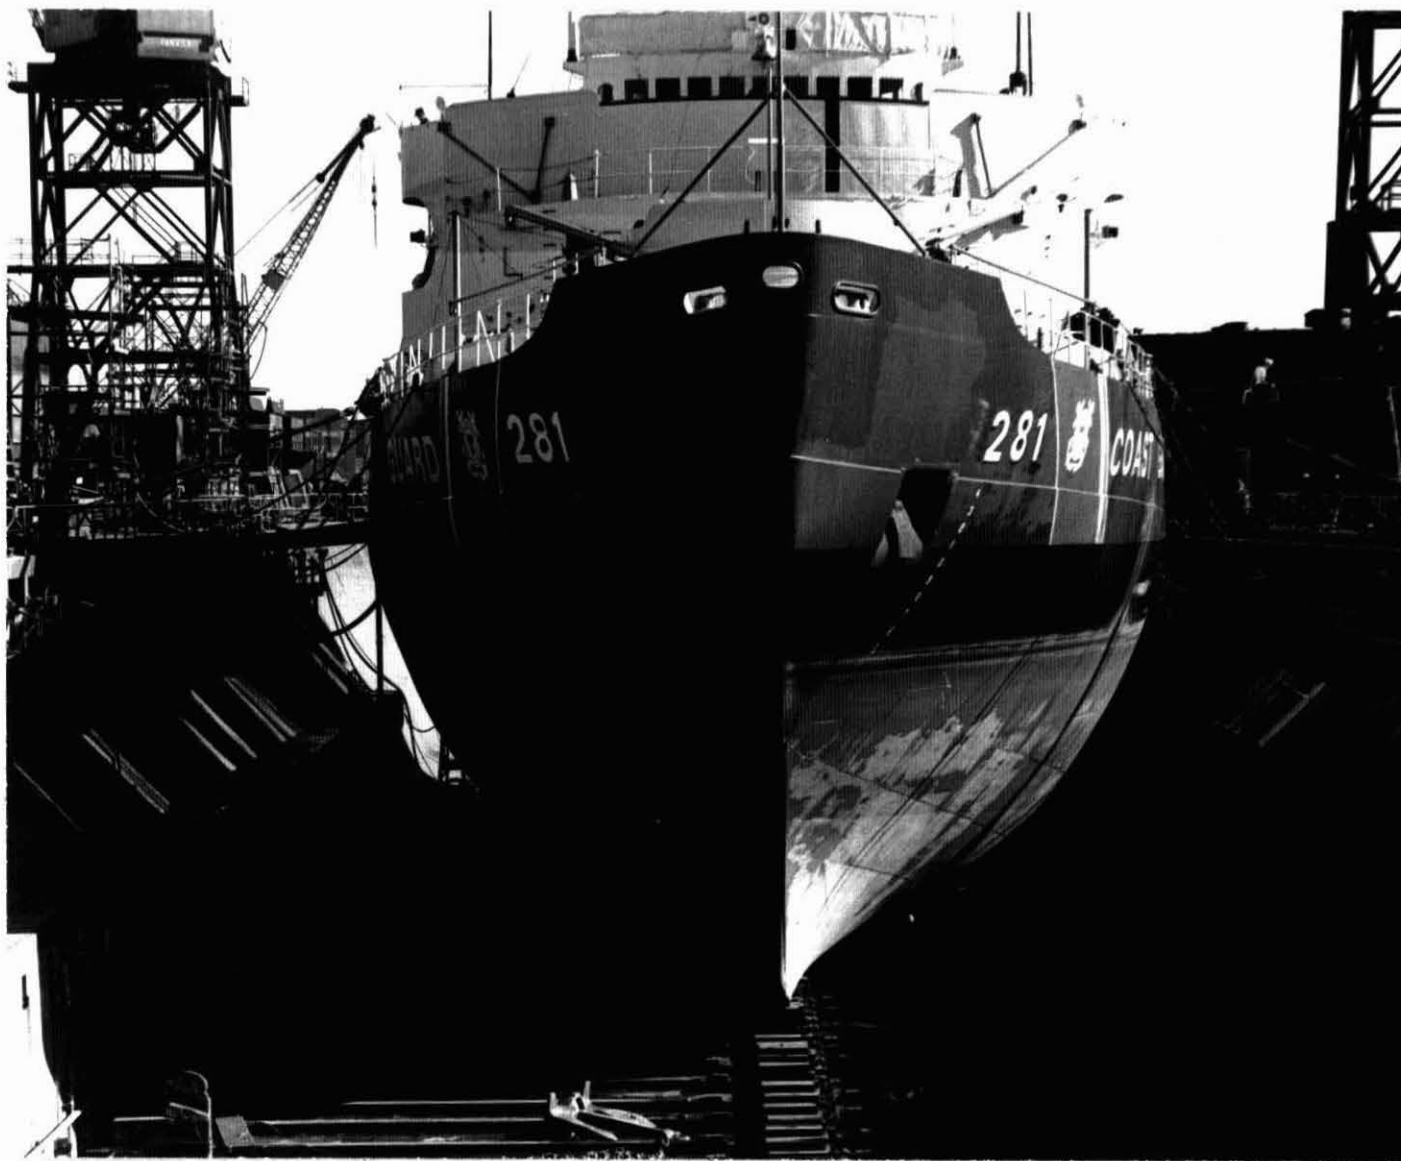
Figure II-26 Condition of the Bow of the USCG Cutter West Wind after Icebreaking Service. The white areas are the glass flake polyester coating. The grey areas are the steel surface where the coating was removed.

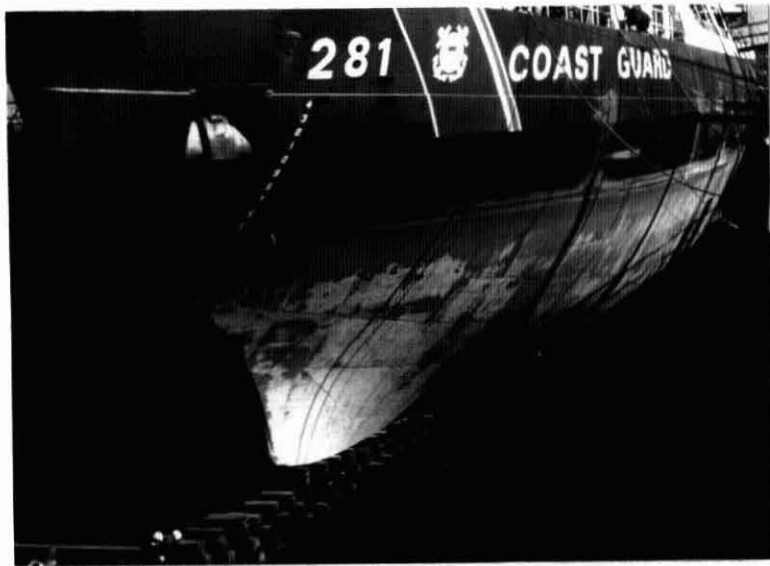
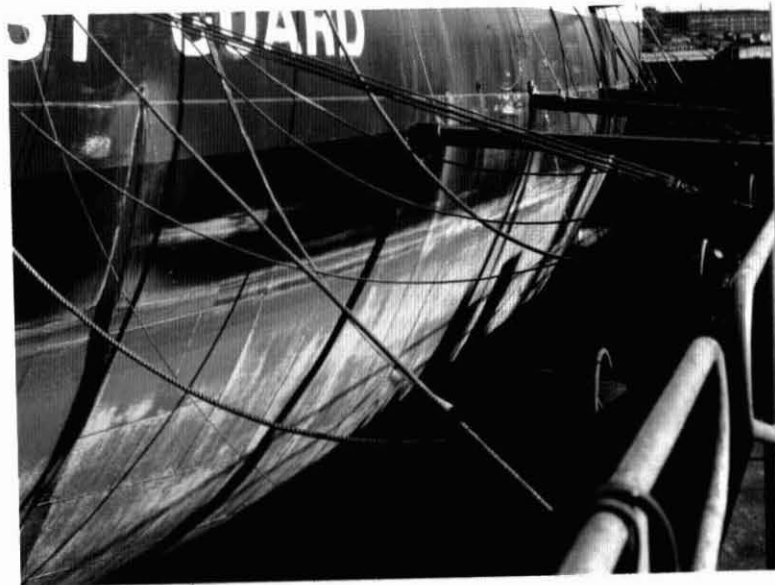
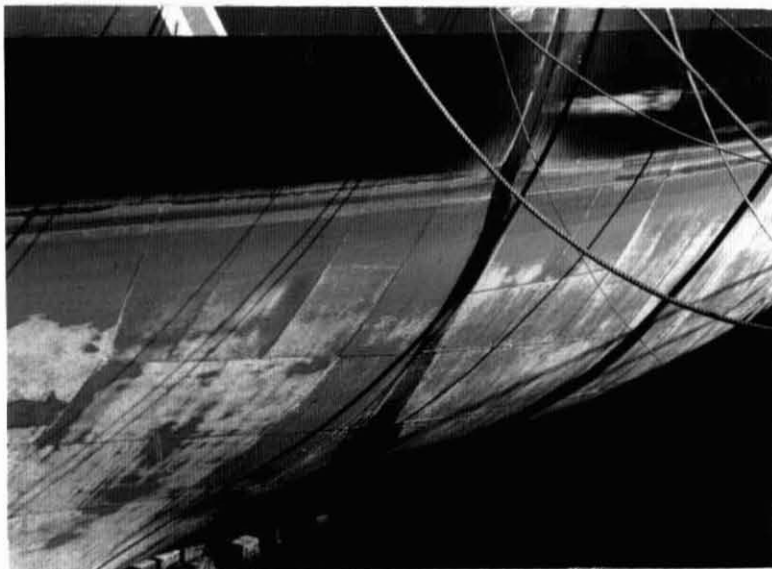
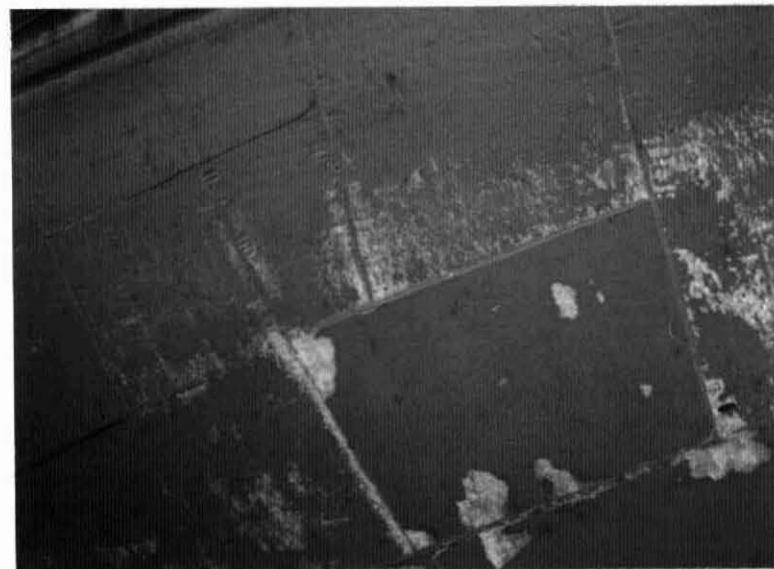
Figure II-27 Condition of the Hull of the USCG Cutter West Wind after Icebreaking Service.
Areas shown are from the bow to midship.

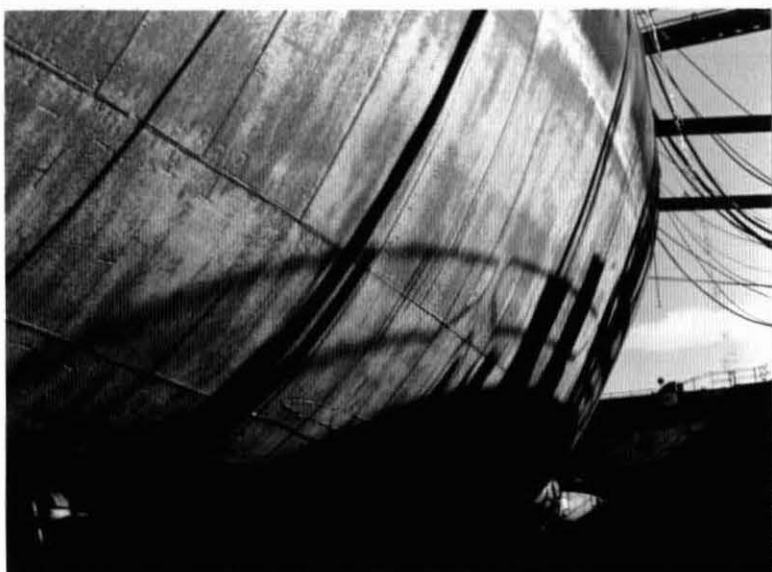
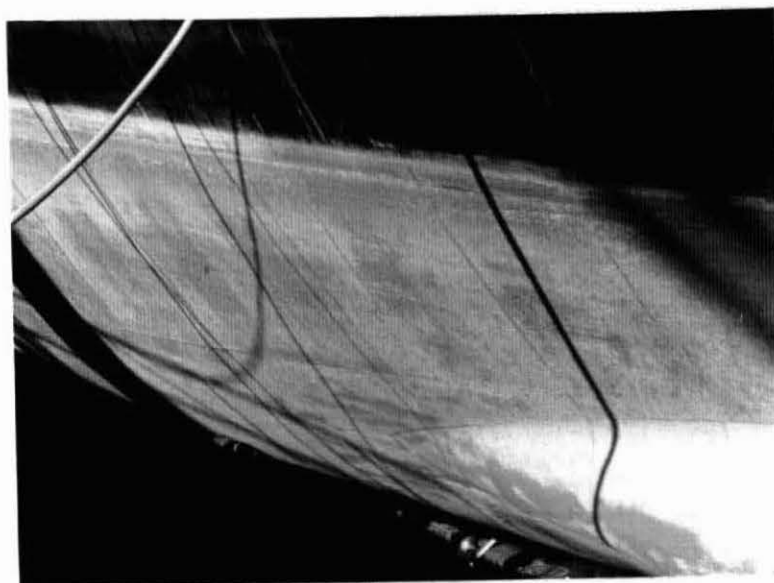
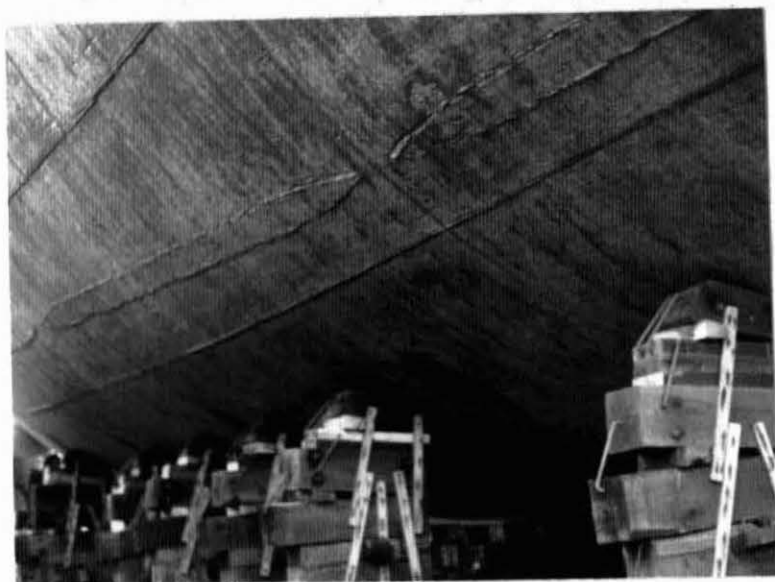
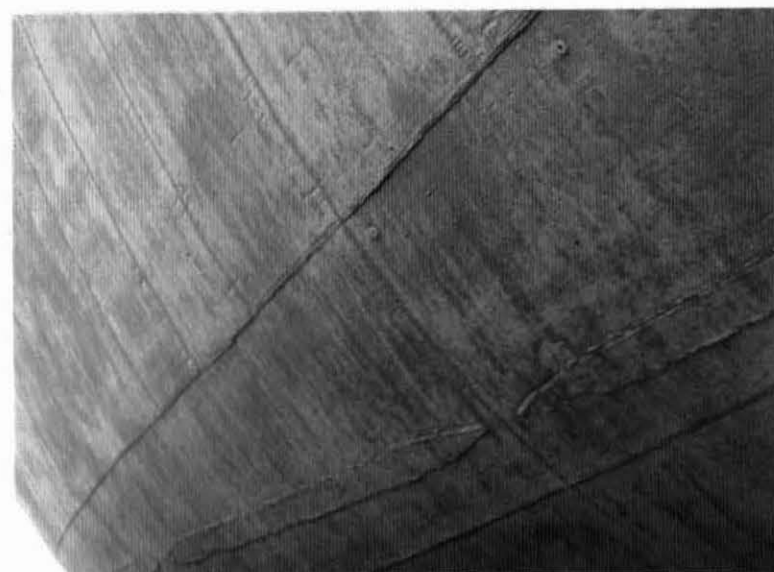
Figure II-28 Condition of the Hull of the USCG Cutter West Wind after Icebreaking Service.
Areas shown are the stern and underside portion of the hull.

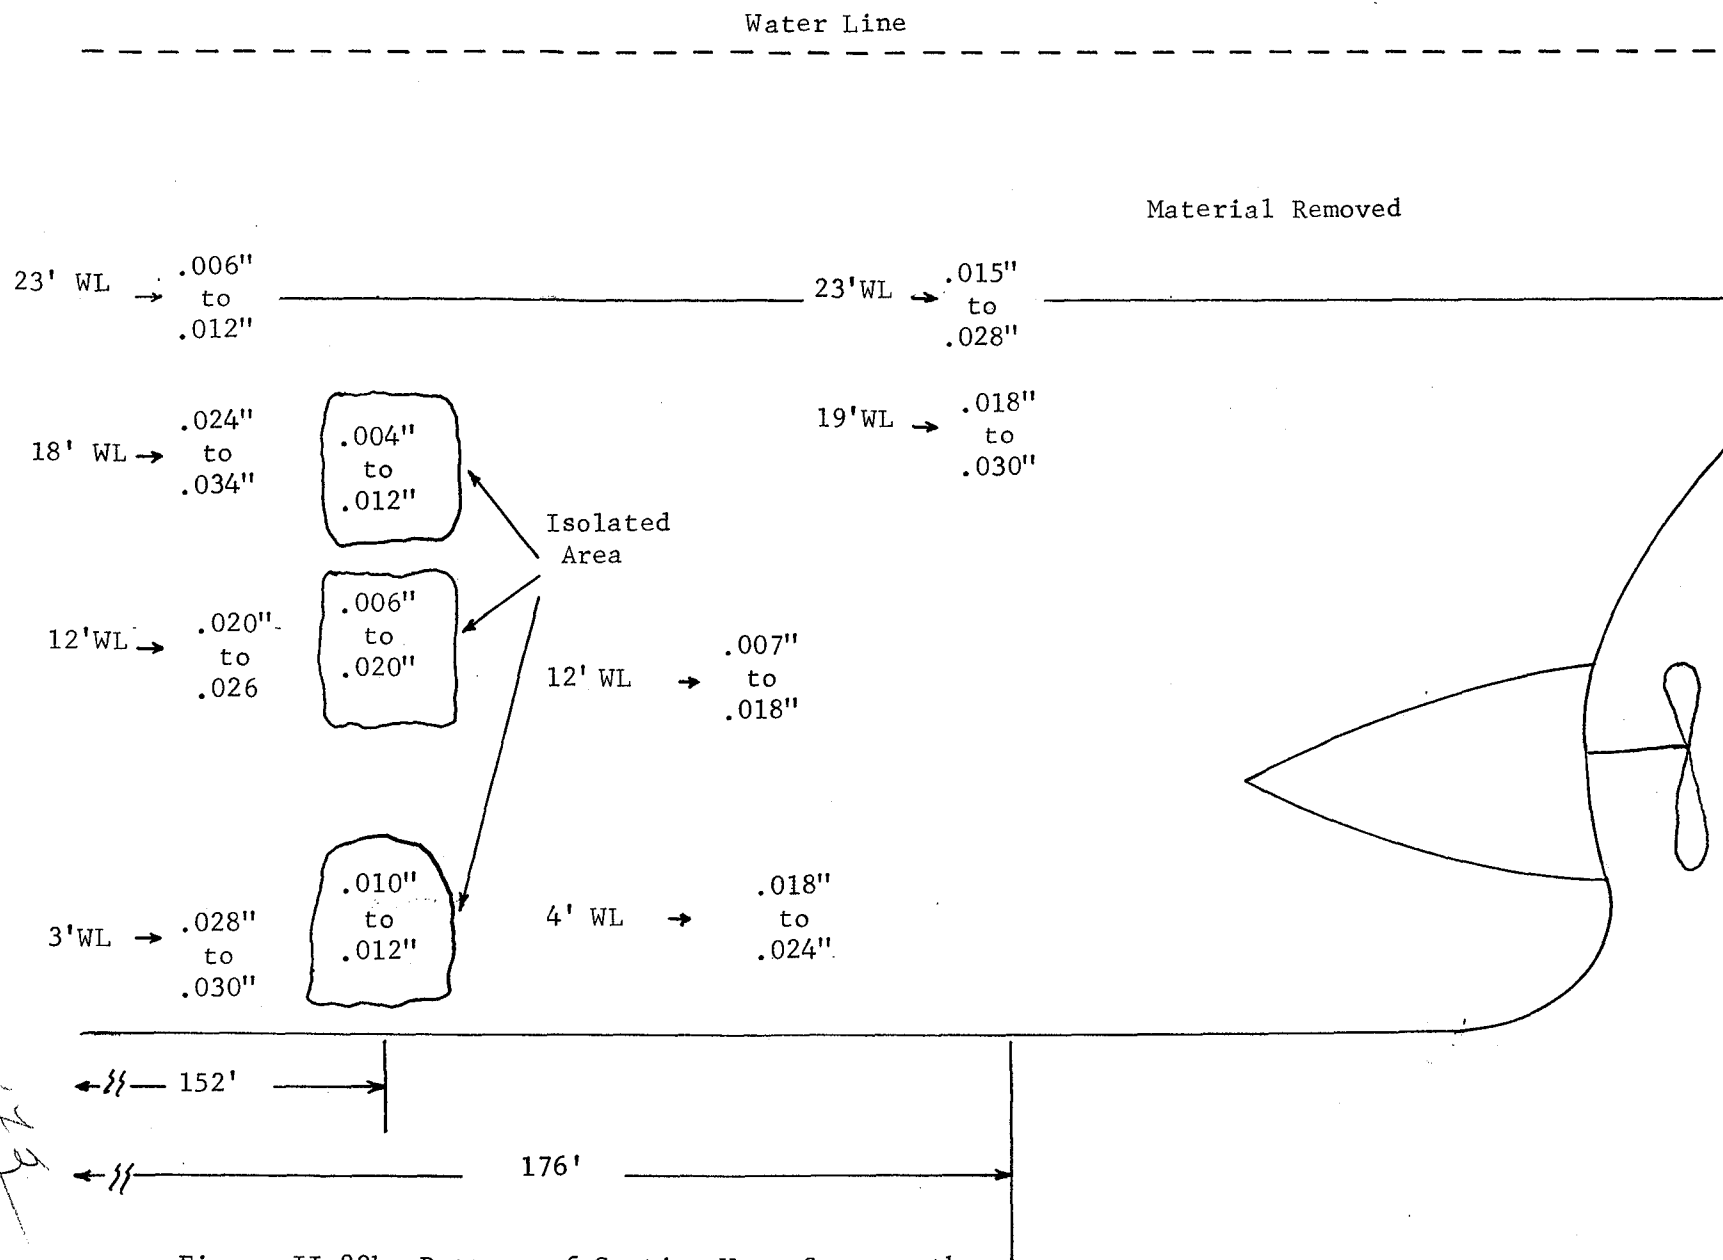
Figure II-29b Pattern of Coating Wear Seen on the USCGC West Wind after Service
